Hitachi and Daicel Develop Image Analysis System to Detect Signs of Facilities Failures and Deviations in Front-line Worker Activities

Contributes to increased quality and productivity through linked operations of manufacturing execution systems

Tokyo, July 13, 2016 -- Hitachi, Ltd. (TSE:6501, "Hitachi") announced today that in collaboration with Daicel Corporation(TSE:4202, "Daicel"), it has developed an image analysis system that supports quality improvements and increased productivity by detecting signs of operational failures in production line facilities and deviations in worker activities on the front lines of manufacturing.

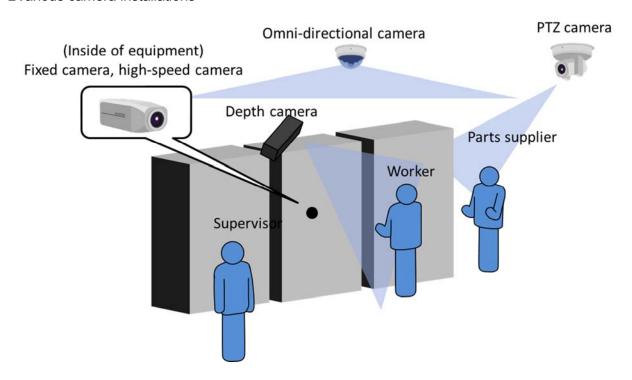
Category	Analysis targets	Sensing methods
Man	Worker activities	Depth cameras
	Position of supervisors and parts suppliers	Omni-directional cameras
Machine	Location of work abnormalities, welding defects	Fixed cameras, high-speed cameras
Material	Parts supply	PTZ cameras ^{*2}

^{* 2} PTZ (Pan, Tilt, Zoom) camera: A camera that can capture subjects in high resolution with pinpoint accuracy

■Various camera installations

This image analysis system uses depth cameras to extract 3-D forms in order to measure worker activities from the "3M" perspective mentioned above, and obtains positional information on human joints, such as hands, elbows, and shoulders. Then, based on frontline interviews and observations, it derives standard behavior models that exclude information not directly related to tasks (e.g., the length of arms and legs), and identifies deviations in worker activities by using statistical comparisons with those standard behavior models. The system also detects abnormalities in the case of defects in materials and facilities by analyzing differences compared to video images under normal conditions. In addition, the system is able to detect abnormalities in the case of welding defects, by combining voltage and current data from existing facilities with light emitting element color analysis using high speed cameras. In this way, the system quickly extracts only information related to improvements in quality and productivity from huge volumes of video data, and combines this function with data analysis to improve work efficiency and quality stabilization, and to quickly discover defects. In addition, by accumulating image data and connecting final products based on individual product serial numbers, this image analysis system can detect production processes which cause defected products, and improve them. Furthermore, when inappropriate operation is detected, it can trace final products based on serial numbers, thus achieving multi-traceability.
